Manhole Inspection Summary

Manhole # S43E__020MH

Insp Date: **1/5/09 10:21 AM**

Location Address: **1600 E BALTIMORE ST**

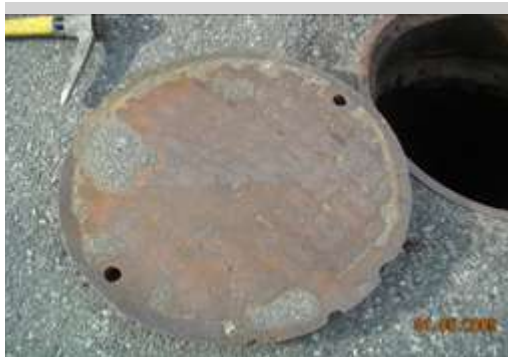
Miscellaneous

Condition: **Worn**

worn cover

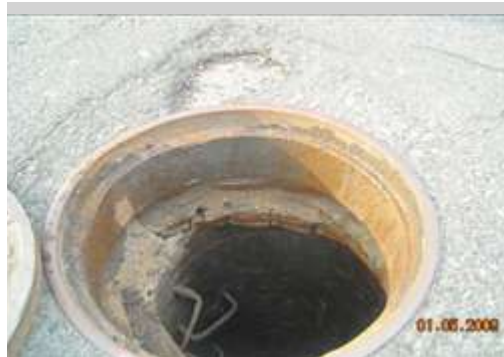
Miscellaneous

Subject To Ponding: **Sheeting**

evidence of inflow from sheeting

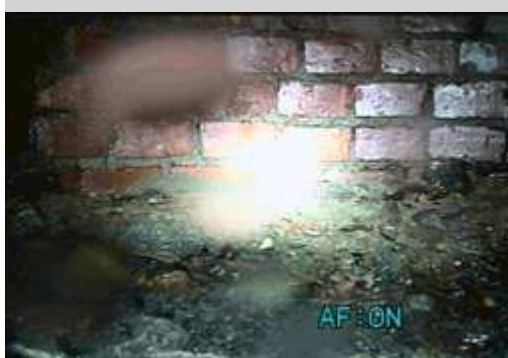
Miscellaneous

bench debris

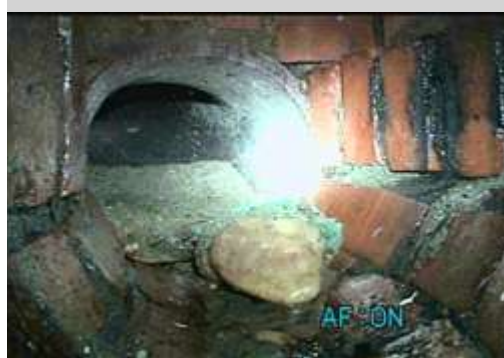
Miscellaneous

channel debris

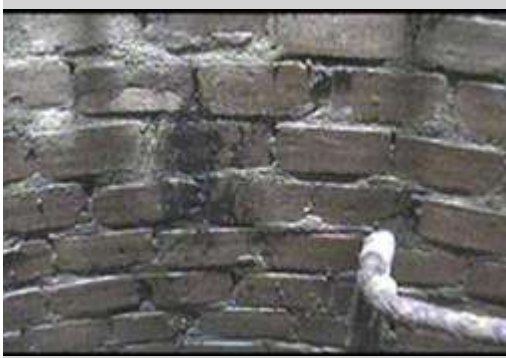
Defect 4

Infiltration: ☐ None ☐ Joint ☐ Cracks ☒ **Mortar** ☐ Roots ☐ Wall

INFILTRATION @ BARREL MORTAR

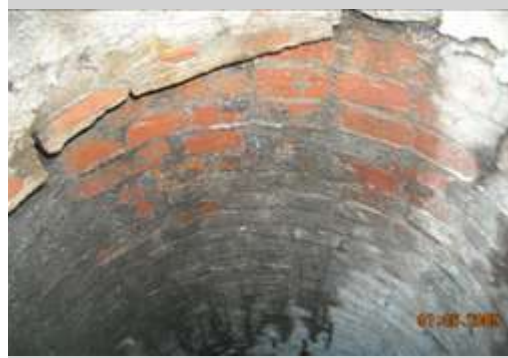
Defect 3

Infiltration: ☐ None ☒ **Joint** ☐ Cracks ☐ Mortar ☐ Roots ☐ Wall

INFILTRATION @ CORBEL/CHIMNEY JOINT

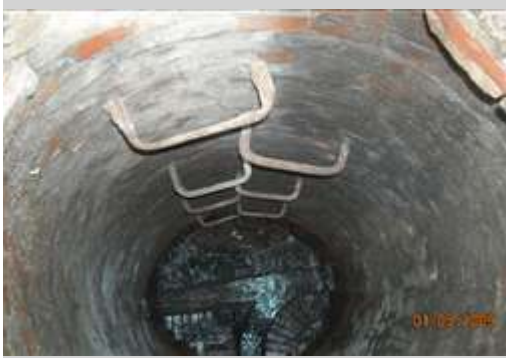
Defect 2

Count: **8** Missing: **0** ☒ **Corroded**

CORRODED STEPS

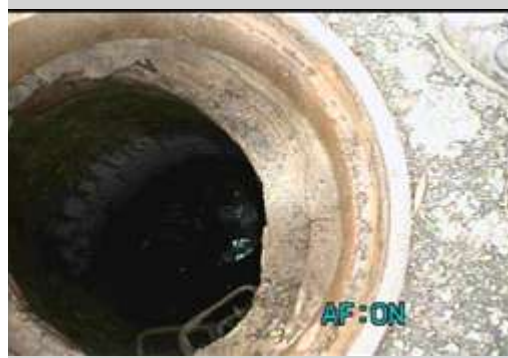
Defect 6

Offset: **6** (in.)

offset

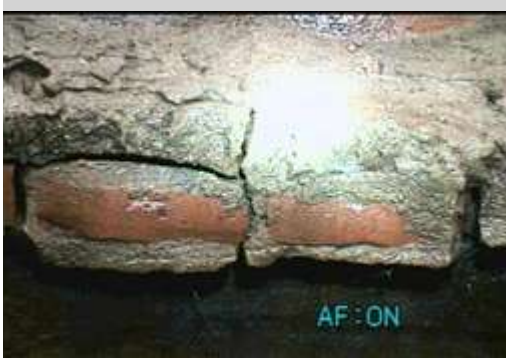
Defect 5

Condition: ☐ Sound ☒ **Cracked** ☐ Root Intrusion ☐ Loose Brick ☐ Deteriorated

cracked frame adj

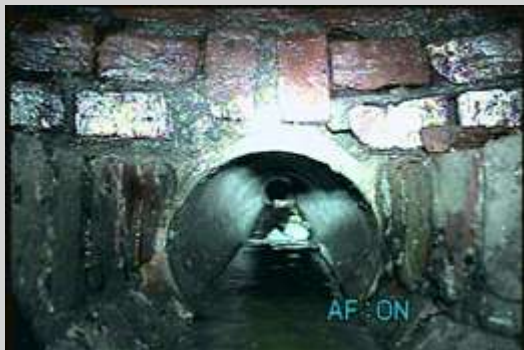
12 O'Clock Outflow

Pipe Height: **8.4** (in.) Rod and Bar (Angled)
Pipe Material: **Clay** ☐ Pipe Lined
Invert Depth: **13.89** (ft.) Flow Characteristics: **Slow**
Deposits: ☐ None ☒ **Mud** ☐ Sludge ☒ **Debris** ☐ Grease
Silt Depth: **2** (in.) Deposits Extent: **Light**
Infiltration: **None** Pipe Seal Cond: **Sound**

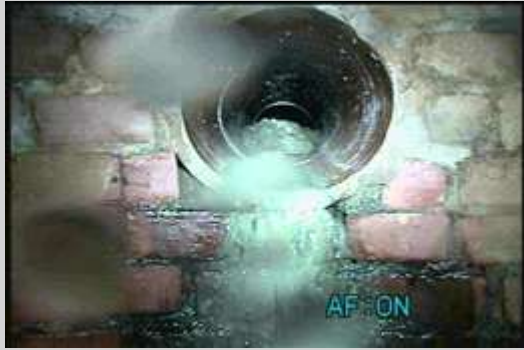
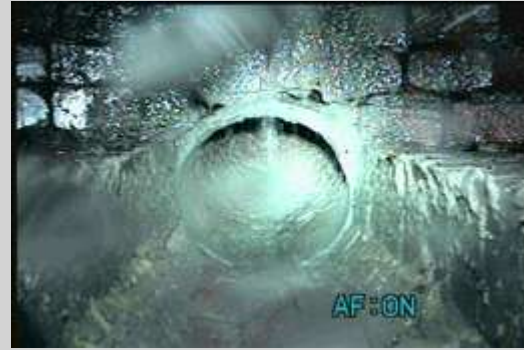
6 O'Clock Inflow

Deposits: ☐ None ☐ Mud ☐ Sludge ☒ **Debris** ☐ Grease

Silt Depth: **0** (in.) Deposits Extent: **Medium**

Drop Condition: **Partly Clogged**
